Problem - Diagnose - Cause

Torsional vibration damper

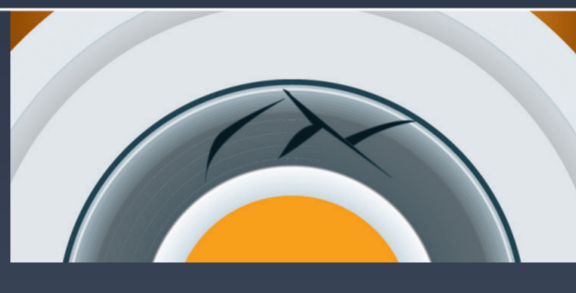
Problem		Diagnosis / Cause
Torsional vibration damper		
<p>Micro cracks There are fine cracks in the rubber track.</p>	 	<p>Hardening of the surface due to aging, which eventually results in failure of damper.</p>
<p>Total Failure The outer ring has separated. The torsional vibration damper is destroyed.</p>	 	<p>Overheating on the outer ring as a result of belt slippage.</p>
<p>Crack formation 45° - Cracks in the vibration isolation track.</p>

Torsion vibration damper should be checked for cracking, deformation and signs of corrosion every 60,000 km. Replacement is advisable every 120,000 km, since not every case of aging/ overload is clearly evident in the form of a defect pattern, although it very much impairs the proper functioning of the engine nonetheless. For many applications, the mounting bolts and sealing rings, which are contained in the original Multi V-belt + Torsional vibration damper Kit, must also be replaced.

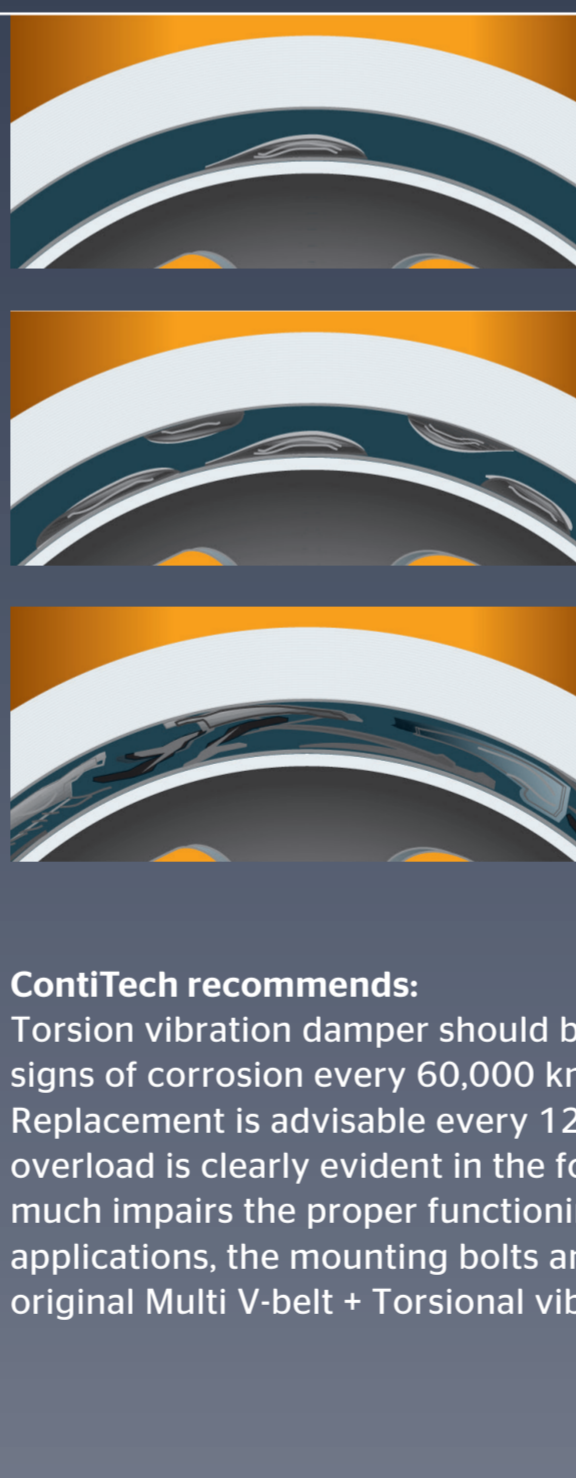
<p>Damage due to extremely high use of idling position, e.g. a taxi.</p>
<p>Breakouts The rubber tracks show breakouts in the area transitioning from rubber to metal.</p>	<p style="text-align: center;">History</p>

<p>Overload, e.g. due to Chip Tuning, results in marked recesses on the surface, which, if this continues, will lead to breakouts and a failure in the torsion vibration damper. The deterioration starts on an inner, non visible area of the rubber track.</p>

Test after 60,000 km		Replacement at 120,000 km
