Problem - Diagnose - Cause

Torsional vibration damper

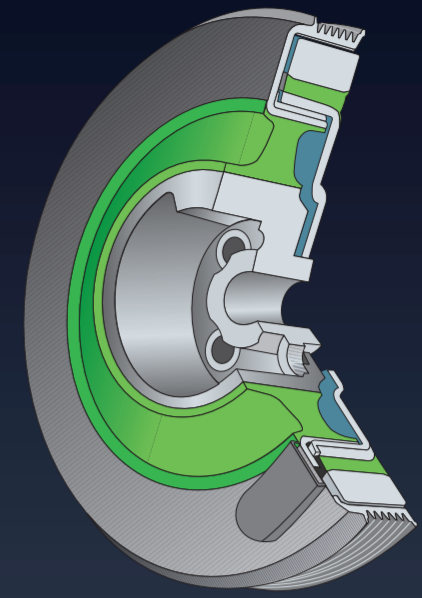
Problem		Diagnosis / Cause
Torsional vibration damper		
<p>Micro cracks There are fine cracks in the rubber track.</p>	 	<p>Hardening of the surface due to aging, which eventually results in failure of damper.</p>
<p>Total Failure The outer ring has separated. The torsional vibration damper is destroyed.</p>	 	<p>Overheating on the outer ring as a result of belt slippage.</p>
<p>Crack formation 45° - Cracks in the vibration isolation track.</p>

ContiTech recommends:

Torsion vibration damper should be checked for cracking, deformation and signs of corrosion every 60,000 km. Replacement is advisable every 120,000 km, since not every case of aging/ overload is clearly evident in the form of a defect pattern, although it very much impairs the proper functioning of the engine nonetheless. For many applications, the mounting bolts and sealing rings, which are contained in the original Multi V-belt + Torsional vibration damper Kit, must also be replaced.
